Channel Mitigation Monitoring Sheets I, II, III, AND IV

Project Title: I-2511CB (I-85 Widening) COE Action ID: 200221534
Stream Name: Town Creek (Site 5) DWQ Number: 040271
City, County and other Location Information: Rowan County, I-85 Widening (-TI-PINC Sta. 20+35)
Date Construction Completed: Water turned on 12/6/06, Stream reforestation completed 12/13/06
Monitoring Year: (3) of 5
Ecoregion: _____ 8 digit HUC unit 03040103
USGS Quad Name and Coordinates: _____

Year 3 Summer – September 2010

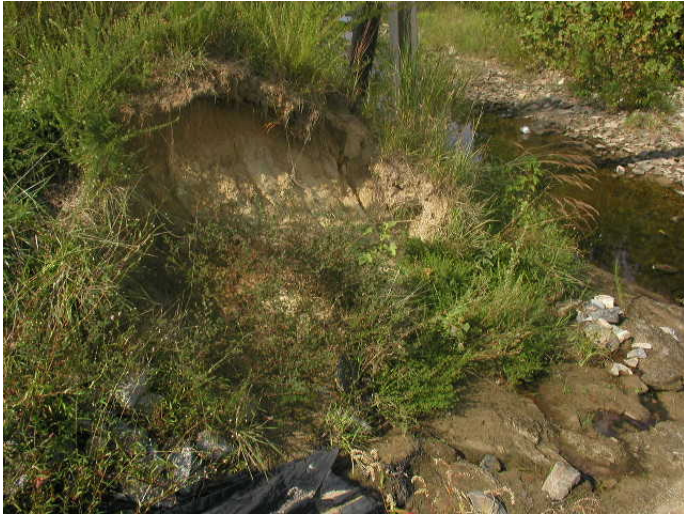
The Town Creek stream relocation is stable for the Year 3 Summer evaluation, except for some bank erosion on the left bank in front of a rock structure at Sta. 16+50. Some bank erosion was also noted on the right bank at Sta. 13+00 where a drainage ditch exits into the stream relocation. NCDOT live staked the eroded areas in March 2010 to help stabilize the banks. These areas have showed little or no change since the last evaluation. NCDOT will continue to monitor this stream relocation.

Erosion on right bank @ -TI- PINE Sta. 13+00

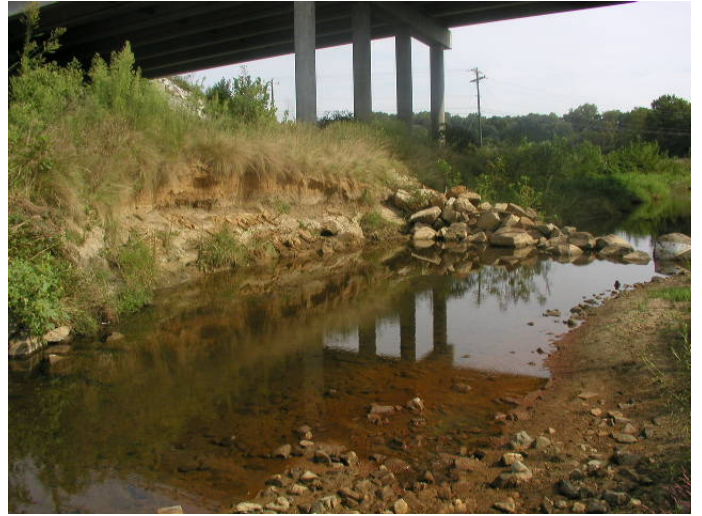
Erosion on left bank @ -TI- PINE Sta. 16+50
